**THE APPLICATION OF AN INTEGRATED MONITORING PLAN ON  
STORMWATER CONTROL MEASURES**

A Thesis

Kathryn L. Greising

August 2011

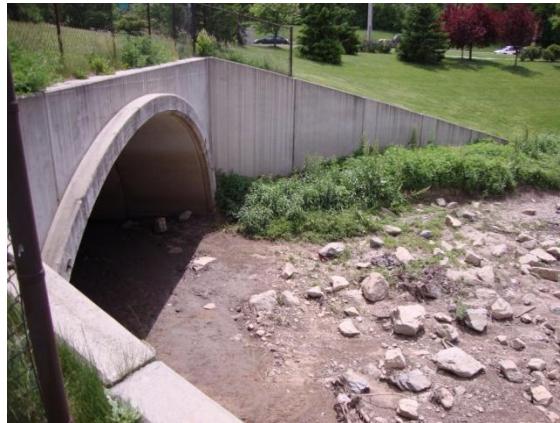
**Figure 5.1: First inlet structure for Metroplex Shopping Center SCM**

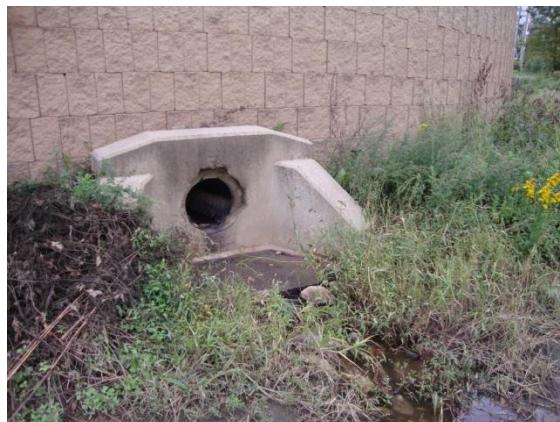
Second inlet structure for Metroplex Shopping Center SCM (Figure 5.2) is smaller, and transfers water from impervious areas into the middle part of the SCM, however, there is adequate space for significant treatment before the water is later released.

**Figure 5.2: Second inlet structure for Metroplex Shopping Center SCM**

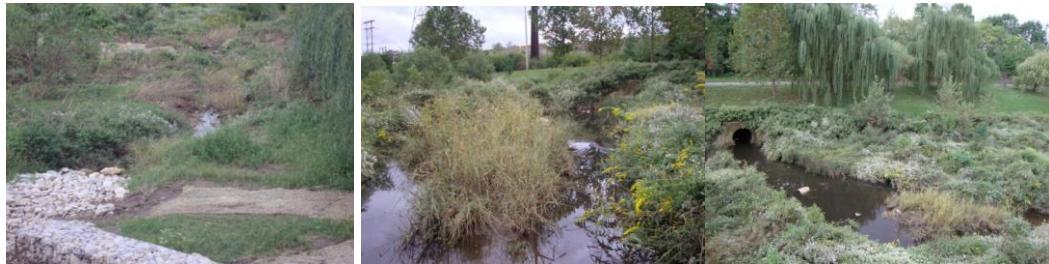
(Figure 5.5). The flow paths were also analyzed for sediment accumulation, clogging and excessive erosion using the checklist described in the methods section. The checklist and corresponding notes are reported in Table 5.1.

**Figure 5.5: Flow paths through Metroplex Shopping Center SCM**

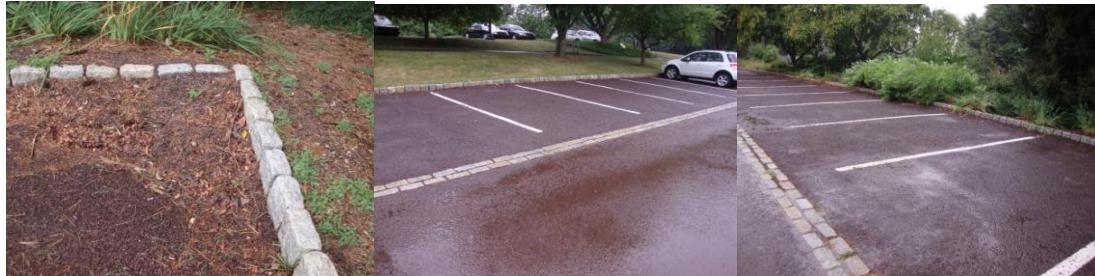
areas which are depicted in Figure 5.7.

**Figure 5.7: Sediment build-up and clogged areas at Morris Arboretum greatly affecting performance**

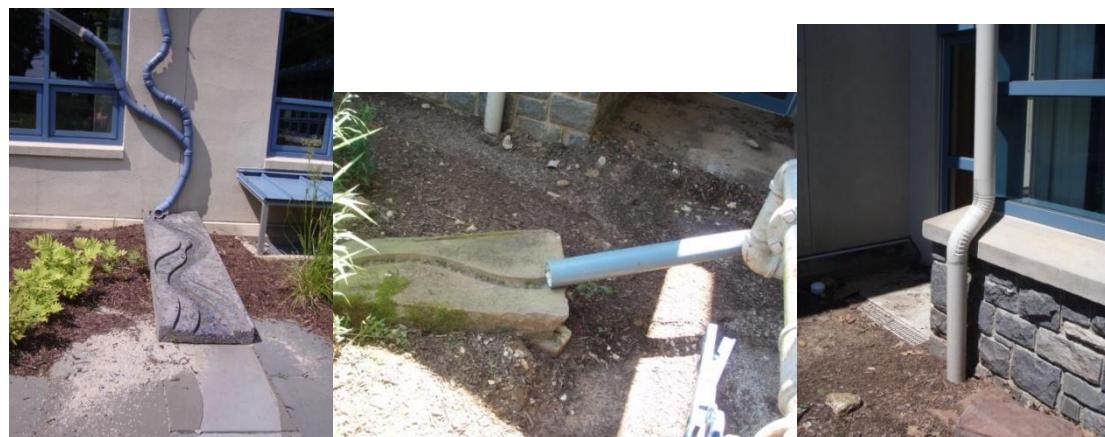
The rain garden at the Springside School was monitored by evaluating the flow paths and drainage problems, the vegetation, underlying soils and infiltration rate of the system. Each of these techniques were used to evaluate the entrance and exiting of the stormwater, the capacity of the system and the potential for evapotranspiration. The flow paths into, throughout and exiting the rain garden were analyzed. There are a number of downspouts transporting water into the rain garden (Figure 5.13).

**Figure 5.13: Inflow pipes transporting water from the roof drains into the rain garden**

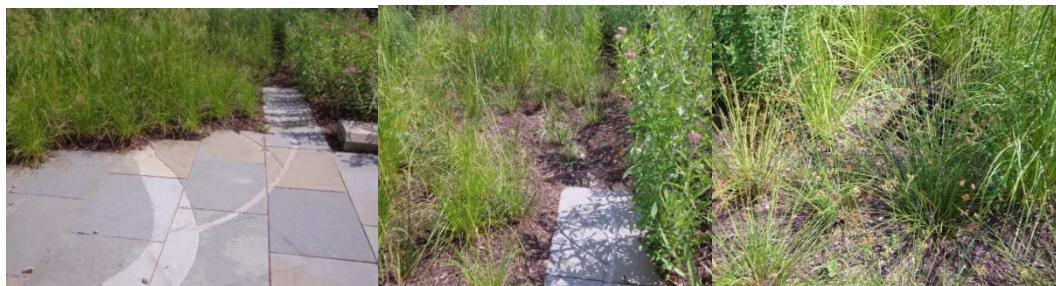
In addition to the downspouts there were a number of flow paths for the water which traveled through the rain garden. The first flow path shown as the pipe to the left in Figure 5.14, traveled directly over a slate walkway, then into the rain garden, but only for a couple feet and then flowed directly into an outflow pipe. This particular flow path provided for minimal storage of the water traveling through the systems and came in contact with very little vegetation. This flow path in particular was not helpful for stormwater remediation, and needs to be altered.

**Figure 5.14: Flow path of first inflow pipe needing improvement**

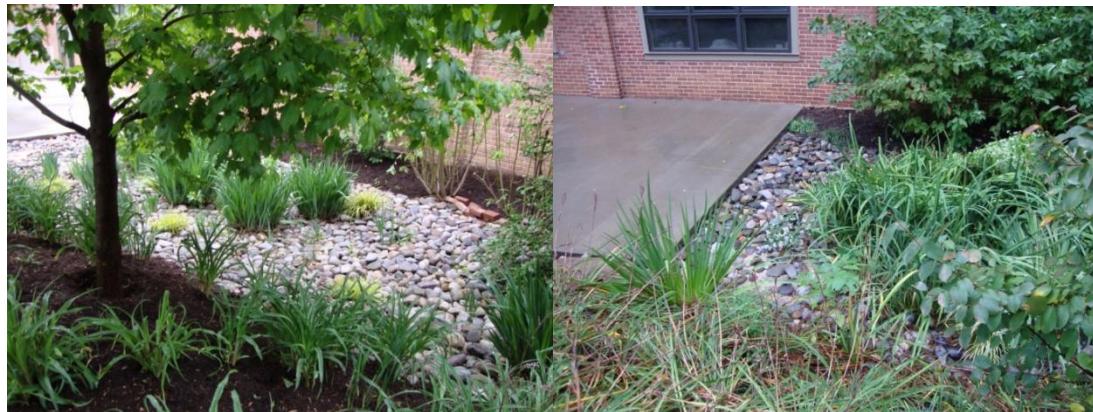
transferred into the rain garden and stored for treatment. There are no significant problems with the flow path. Additional drainage notes are reported in Table 5.8.

**Figure 5.20: Wayne Art Center Rain Garden #1 and inflow area**

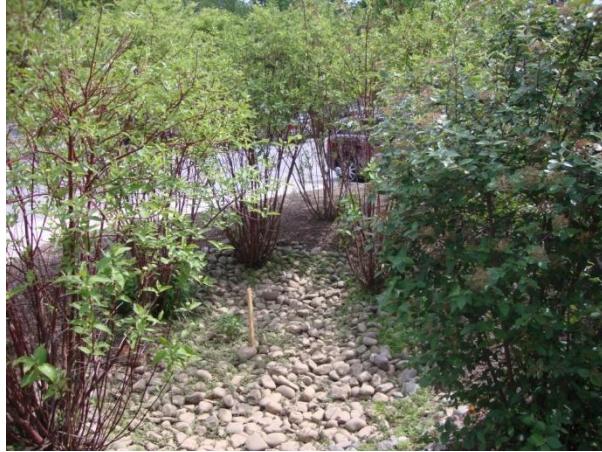
The second rain garden was evaluated in the same manner as Rain Garden #1 and the Springside School Rain Garden. The evaluation includes an analysis of the flow paths, drainage problems, vegetation and soil analysis. A picture of the bowl-shaped rain garden is shown in Figure 5.21. This rain garden was analyzed for drainage problems, the status of the vegetation and the infiltration rate. This rain garden is exceeding expectations.

**Figure 5.21: Rain Garden #2 located at Wayne Art Center**

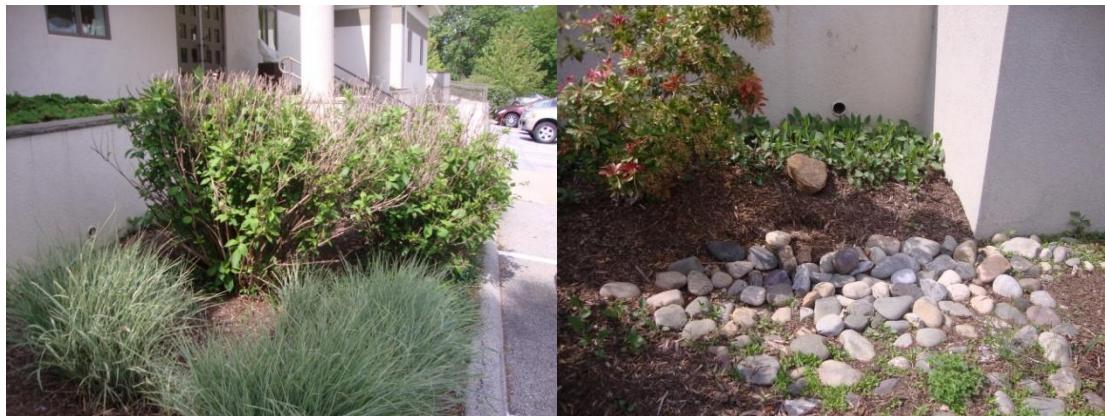
The last rain garden assessed at Wayne Art Center was Rain Garden #3. This rain garden was located farthest from the entrance to the site and covers an area of about 350 square feet. Although the rain garden has a large area, the area in which the stormwater covers the rain garden is much smaller. A picture of the last rain garden is depicted in Figure 5.24. This rain garden was analyzed for drainage problems, the status of the vegetation and the infiltration rate. The rain garden needs improvements.

**Figure 5.24: Inflow pipes directing stormwater into Rain Garden #3 at Wayne Art Center**

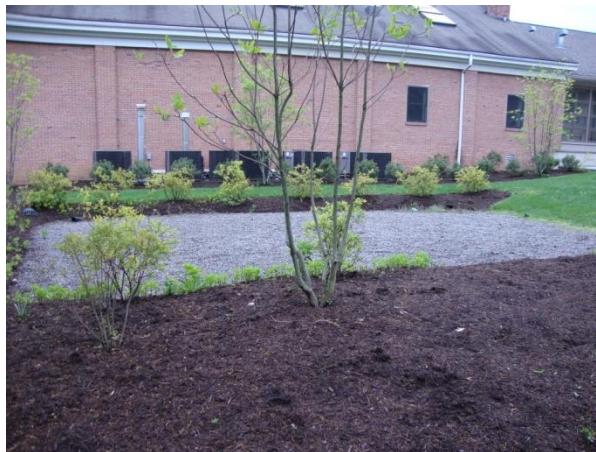
The last stormwater control measure evaluated at the Wayne Art Center was a seepage pit. The seepage pit is approximately 670 square feet, and collects stormwater from the rooftop of the building adjacent to it. A picture of the seepage pit is shown in Figure 5.27. This site was analyzed for drainage problems and flow path problems and was found to meet expectations.

**Figure 5.27: Picture of the seepage pit at Wayne Art Center**
