**THE APPLICATION OF AN INTEGRATED MONITORING PLAN ON  
STORMWATER CONTROL MEASURES**

A Thesis

Kathryn L. Greising

August 2011

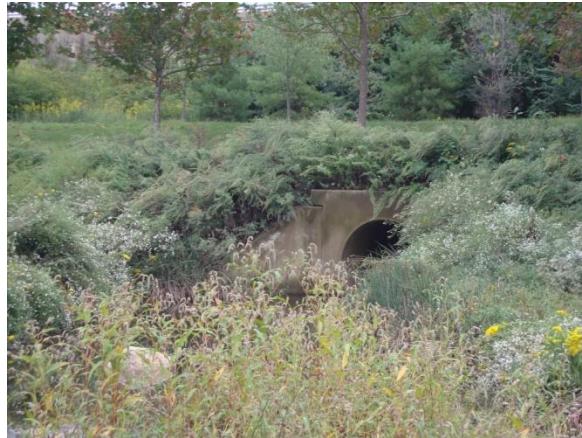
**Figure 5.3: Third inlet structure for Metroplex Shopping Center SCM**

The third inlet (Figure 5.3) takes water from a different area and discharges it in the middle part of the SCM. The fourth inlet (Figure 5.4) is on the same side as the third, just upstream. This inlet is similar to the second and third and is capable of

transferring much less runoff than the first. The combination of inlets provides an adequate transportation of water from adjacent impervious areas into and throughout the Metroplex SCM.

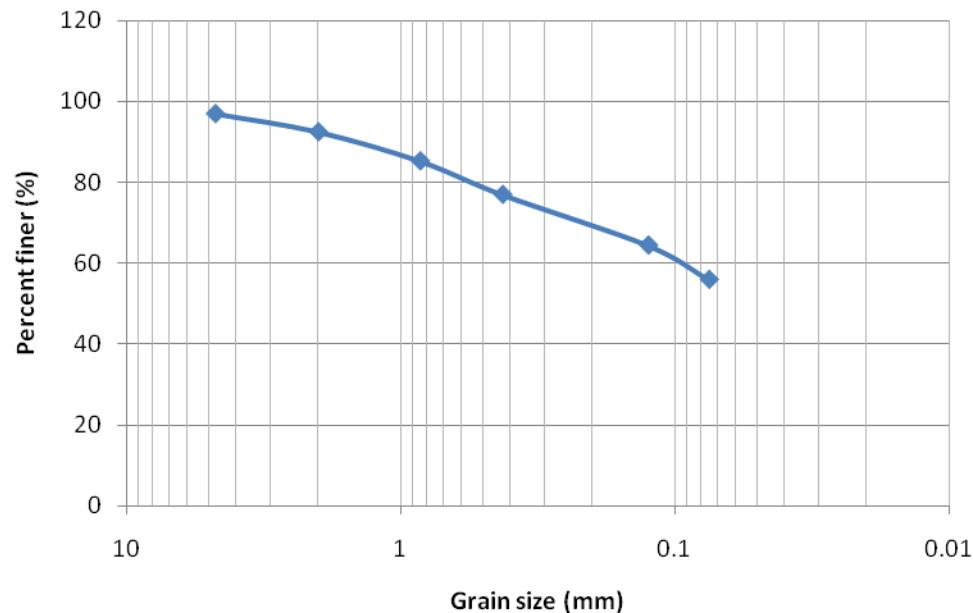
**Figure 5.6: Grain Size Distribution of soils on Metroplex Shopping Center Site**

To gain additional information about the underlying soils throughout the Metroplex SCM, a soil sample was collected on site and transported back to the Soils Laboratory at Villanova University to perform a grain size analysis. The USCS soil classification was found to be an OL or organic clay. The USDA soil group was found to be Group C. Soil group C indicates the presence of fine particles within the soil. Although soil group C is not ideal for infiltration SCMs, the presence of fines does not hinder the performance of the Metroplex SCM because it uses these fines to trap and direct the runoff throughout the area.

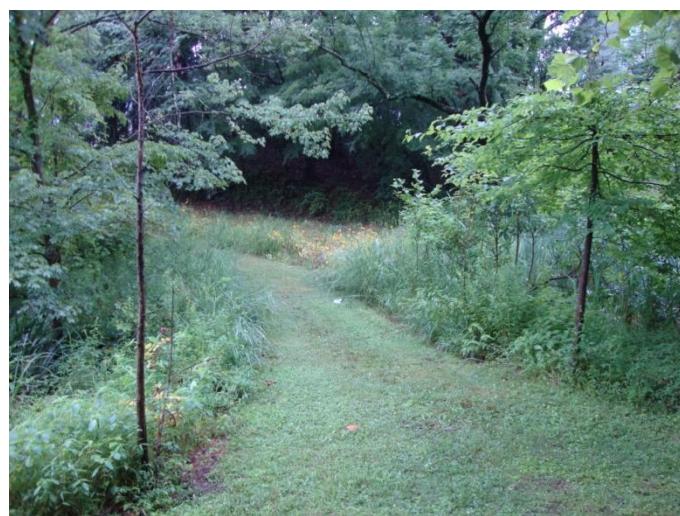
**Figure 5.8: Grass walkway between two wetland areas at Natural Lands Trust**

The flow paths and drainage was analyzed similarly to the first few sites (Table 5.4). The flow paths were very clear for this particular site. The inlet to the wetland included runoff from the rooftop of the adjacent building and sheet flow coming off of the upstream hill. The wetland was then divided into two separate areas. The separation by a grass walkway can be seen in Figure 5.8.

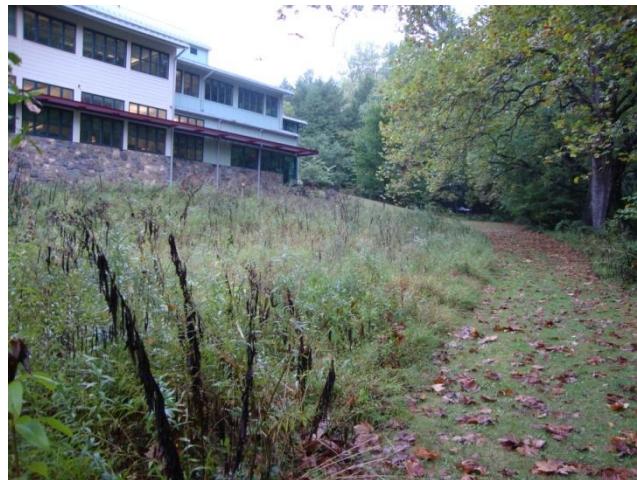
**Figure 5.9: Upstream section of the wetland area located at Natural Land Trust**

The upstream wetland area collects the runoff and begins to treat the stormwater by slowing it down. The area is composed mostly of thick vegetation, and has a shallow bowl shape to it. This shallow bowl shape allows for the water to be collected and transported downstream. The water is treated by slowing the water down, causing larger sediment particles to drop out and allow for interactions to occur between the stormwater and the vegetation. This first section of the wetland can be seen in Figure 5.9.

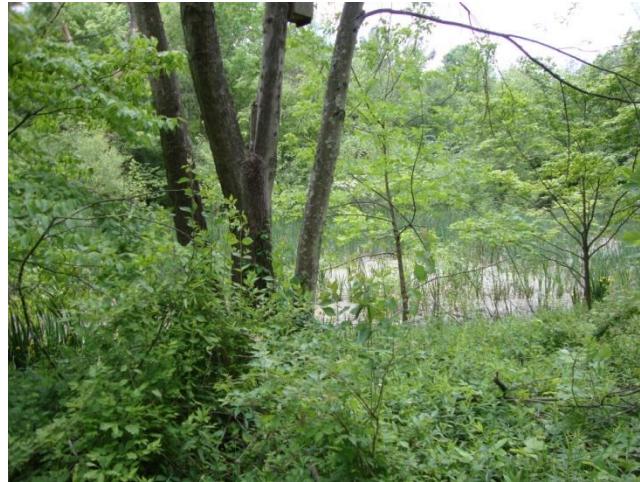
**Figure 5.10: Picture of second wetland area at Natural Lands Trust**

After the water moves to the downstream end of the first wetland, it travels through a pipe underneath the grass walkway to the second wetland area. The second part collects water from the upstream section of the wetland in a sediment forebay area. This area allows for additional settling of the particles in the water as well as

additional plant interactions. A picture taken from the upstream end of the second wetland area can be seen in Figure 5.10.

The flow path through the two wetland areas is sufficient to decrease the velocity and treat the water. Additional notes were taken on the drainage throughout the system and are reported in Table 5.4.

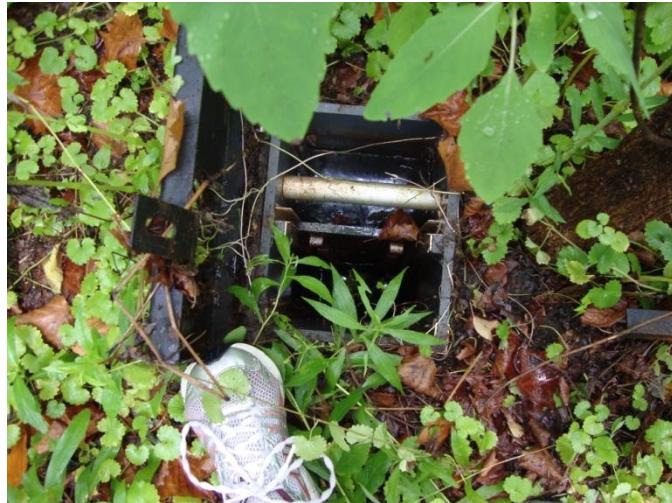
**Figure 5.11: Outlet structure of wetlands at Natural Lands Trust**

In addition to the flow paths through the system, there is also an outlet structure which controls the release of water to the downstream areas (Figure 5.11).

The outlet structure is a weir-type structure that releases a small volume of water once the water reaches a certain level in the wetland. The outlet structure can also be manually released to allow for additional water to drain during larger storm events.

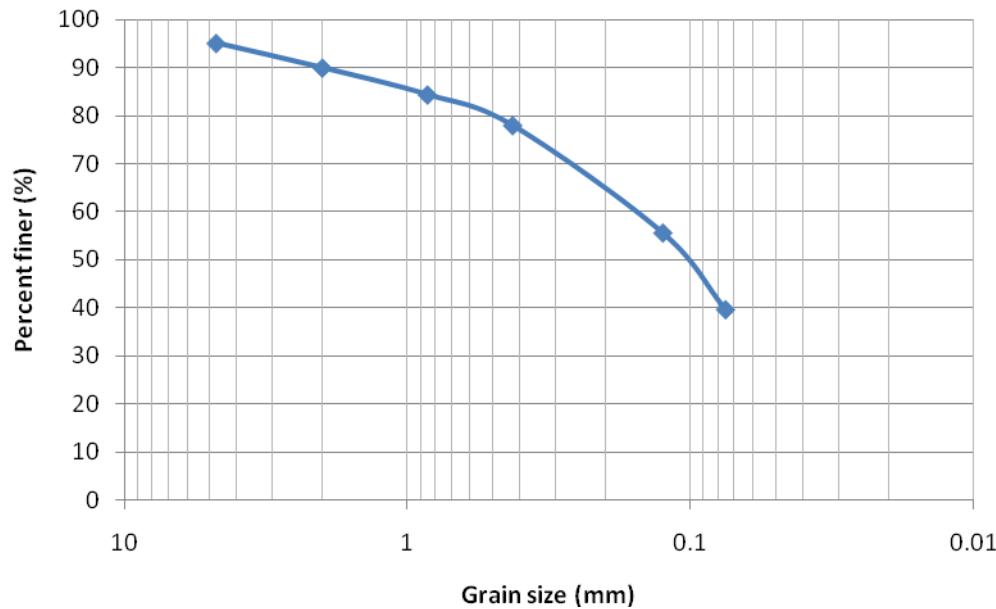
**Figure 5.12: Grain Size Distribution of soils at Natural Lands Trust**

A grain size analysis was performed on the underlying soils at the Natural Lands Trust Constructed Wetland. Constructed wetland systems are typically underlain by finer-grained soils. Finer grained soils, such as clays, allow wetlands to create flow paths for the water and areas of ponding, such as sediment forebays, which can also allow for additional treatment. The grain size distribution is presented in Figure 5.12; according to the USCS the soil is a silty sand or SM soil, and is a Group B soil within USDA Classification system.

A number of factors went into the evaluation of the Natural Lands Trust Stormwater Wetlands. Overall, the wetland was performing as designed and with the addition of regular maintenance and volume controlled structures, the wetland was found to exceed expectations. The flow path was adequate for the system, the entrance of the water through sheet flow over the adjacent grass area and the inflow from the adjacent buildings created a sufficient inflow. The presence of wetland species indicated that the water remained and was treated in the wetland for an extended time, meeting the goals for Constructed Stormwater Wetlands. Although some invasive species were present, they were kept under control through regular maintenance. The underlying soils performed according to design, as they kept the water ponded in a number of areas, while man-made structures allowed for excess discharges to occur when needed. The underlying soil was found to be a silty sand in the adjacent area which would not normally allow for ponding to occur which indicated that the underlying soils within the wetland could differ or a liner could be present as well.

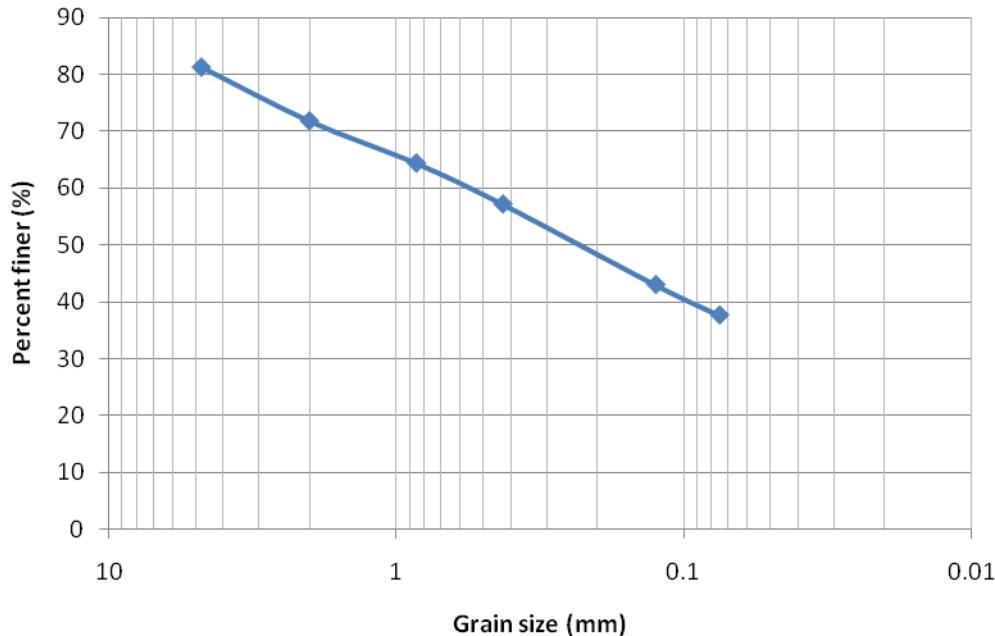
**Figure 5.15: Results for Springside School's Rain Garden Grain Size Distribution Test**

An assessment of the underlying soil and an infiltration test were performed to understand the capacity of the subsurface material for stormwater storage and the potential for the soil to infiltrate into the underlying soils. First a soil sample was retrieved from the site and transported back to the laboratory for a grain size analysis. The results of the grain size distribution can be seen in Figure 5.15. The grain size distribution in conjunction with the plastic and liquid limit tests indicated that the soil

tested was a silty sand (SM) according to the USCS and a USDA soil type B. This soil has adequate infiltration and storage properties.

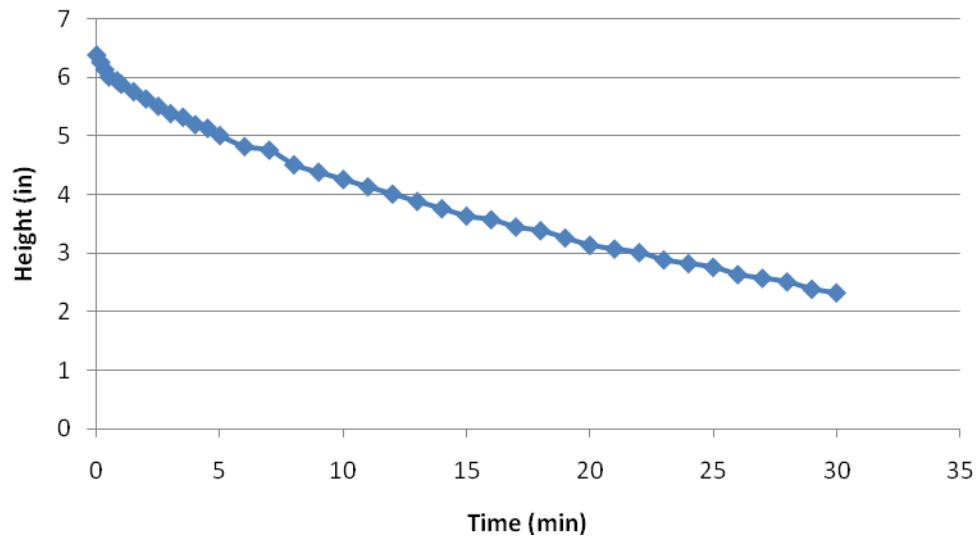
**Figure 5.16: Springside School Infiltration Test Data**

Lastly, an infiltration test was performed on site to gain additional understanding of the performance of the rain garden. The entire infiltration test is shown in Figure 5.16, and the constant slope used to determine the infiltration rate, as mentioned in the methods sections, is shown in Figure 5.17.

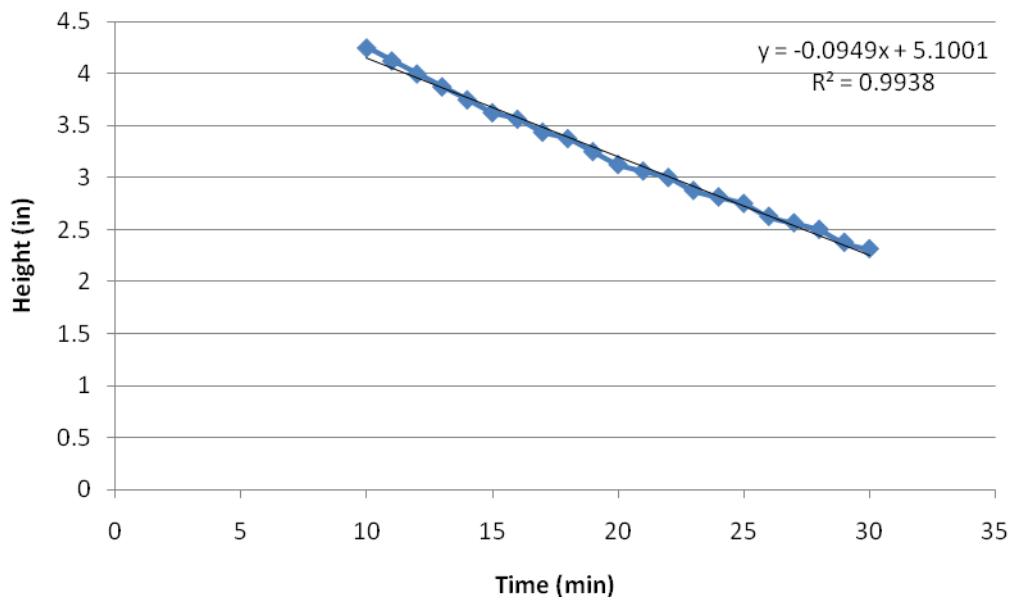
**Figure 5.17: Springside School Infiltration Rate after 10 minutes**

The results from Figure 5.17 indicate that the infiltration rate was approximately 5.64 inches/hour or 0.0040 cm/second. This is a high value for soil and indicates that a large amount of stormwater accumulated into the rain garden is being infiltrating into the soil.

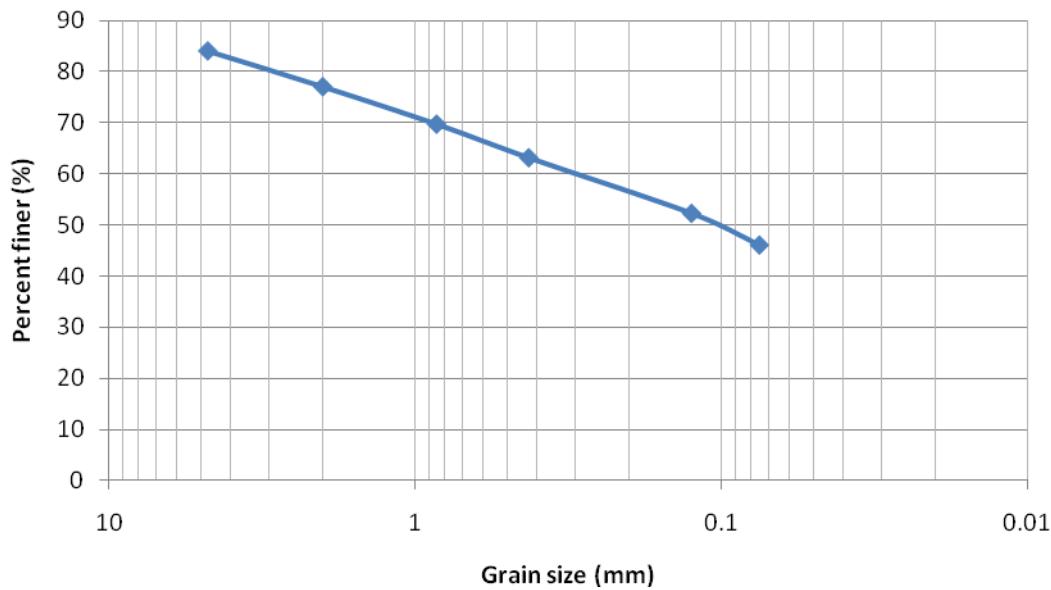
**Figure 5.19: Grain size distribution for underlying soil at the Wayne Art Center**

The grain size distribution in conjunction with the plastic and liquid limit tests indicate that the underlying soil at the Wayne Art Center was a USCS Classification: SM or silty sand, and was classified as the USDA soil type B. This soil type indicates high infiltration rates which is particularly good for the bio-infiltration and infiltration SCMs on site.

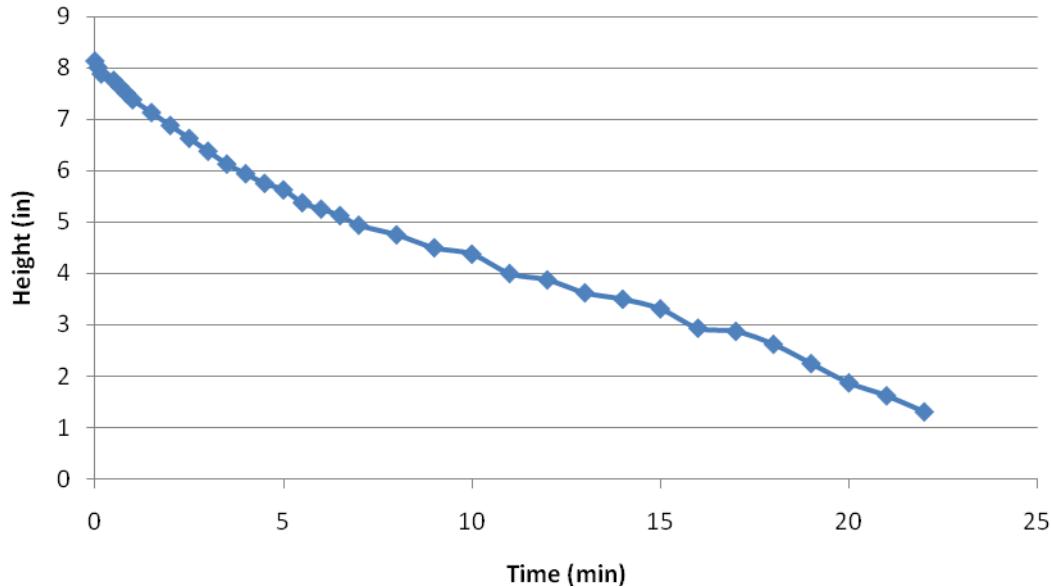
**Figure 5.22: Wayne Art Center Rain Garden #2 Infiltration Test Results**

After the flow path and vegetation were assessed, an infiltration test was performed on site. The results for the single-ring infiltration test are shown in Figure 5.22.

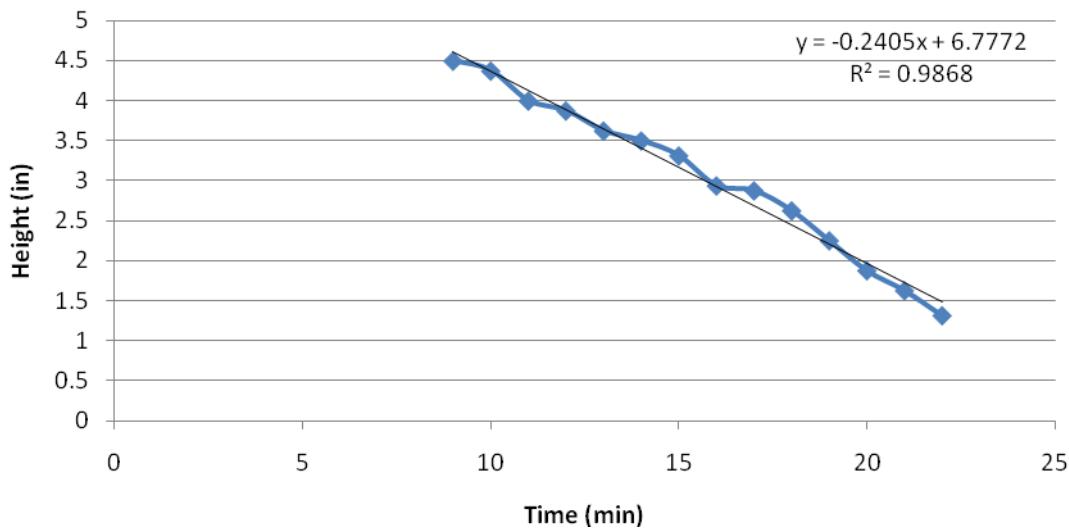
**Figure 5.23: Wayne Art Center Rain Garden #2 Infiltration Rate Approximation**

Using the approximation of the linear trendline, the infiltration rate was found to be about 14.4 inches/hour or 0.010 cm/second. This high infiltration rate indicates that large amounts of water can be transferred through the underlying soil during rain events.

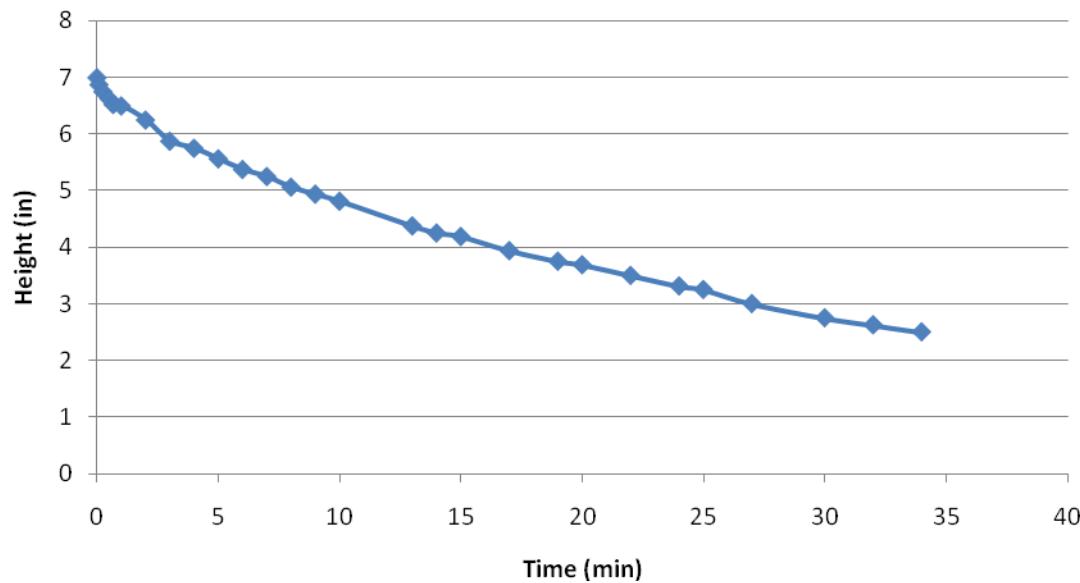
**Figure 5.25: Wayne Art Center Rain Garden #3 Infiltration Test Results**

The infiltration test was performed in the area of the rain garden where stormwater can pond (the rocky area), which can be seen in Figure 5.24. The results from this infiltration test are shown in Figure 5.25.

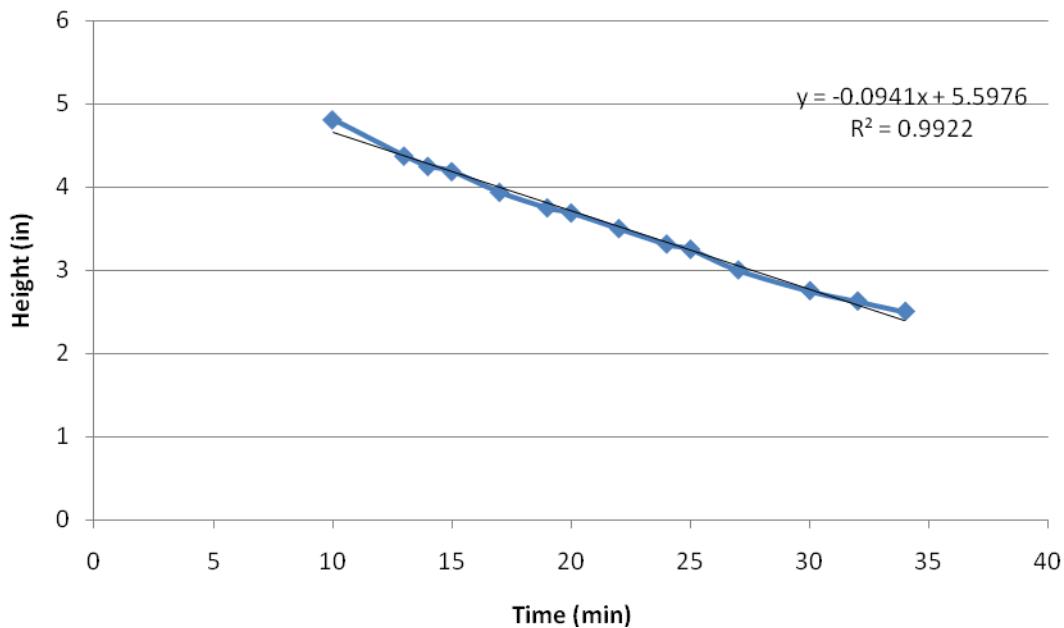
**Figure 5.26: Wayne Art Center Rain Garden #3 Infiltration Rate Approximation**

Using the approximation above, the infiltration rate for the third rain garden at the Wayne Art Center was found to be 5.64 inches/hour or 0.0040 cm/second. This is an adequate infiltration rate for stormwater to move through the underlying media.

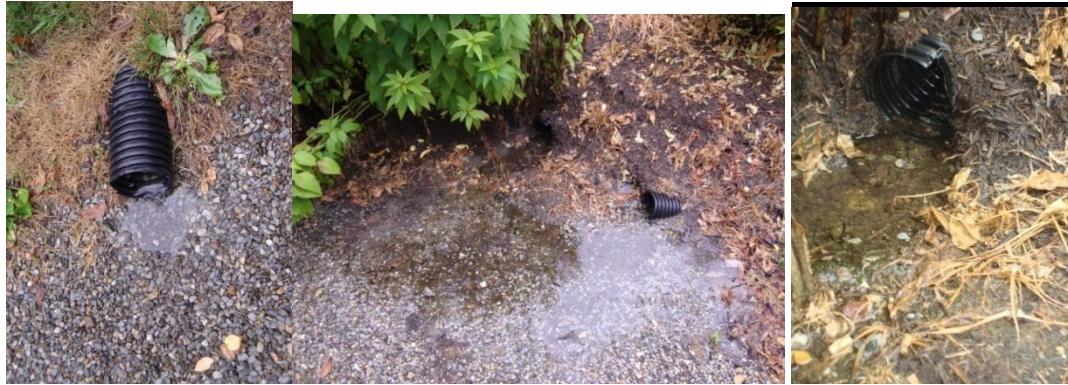
**Figure 5.28: Inflow pipes routed from rooftop drain to seepage pit**

Although the pipes are performing as they should by transferring water from the rooftops to the seepage pit, there is significant ponding of the stormwater around the exit point of the pipes. The stormwater is not being dispersed over the entire seepage pit, and therefore the maximum storage potential of the pit is not being used. Additional notes taken on this phenomenon are reported in Table 5.14.
